TECHNICAL INSPECTION REPORT

U.S.S. PARCHE (SS384)

TEST ABLE

OPERATION CROSSROADS

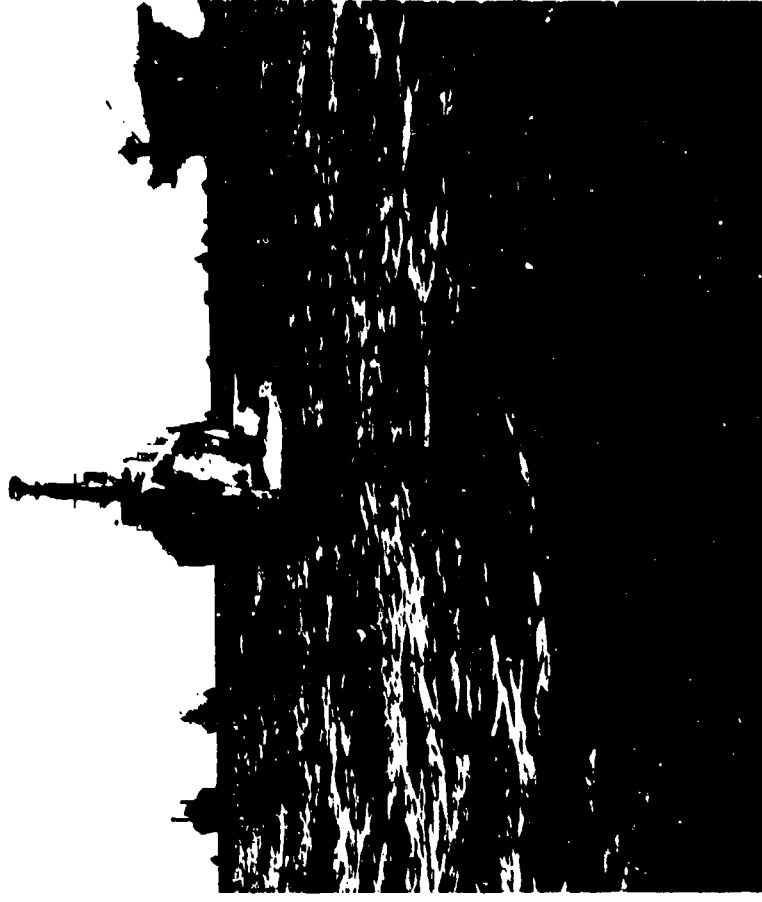
BB-CR-227-513-30. General view of bow, showing scorching of paint on the port side forward.

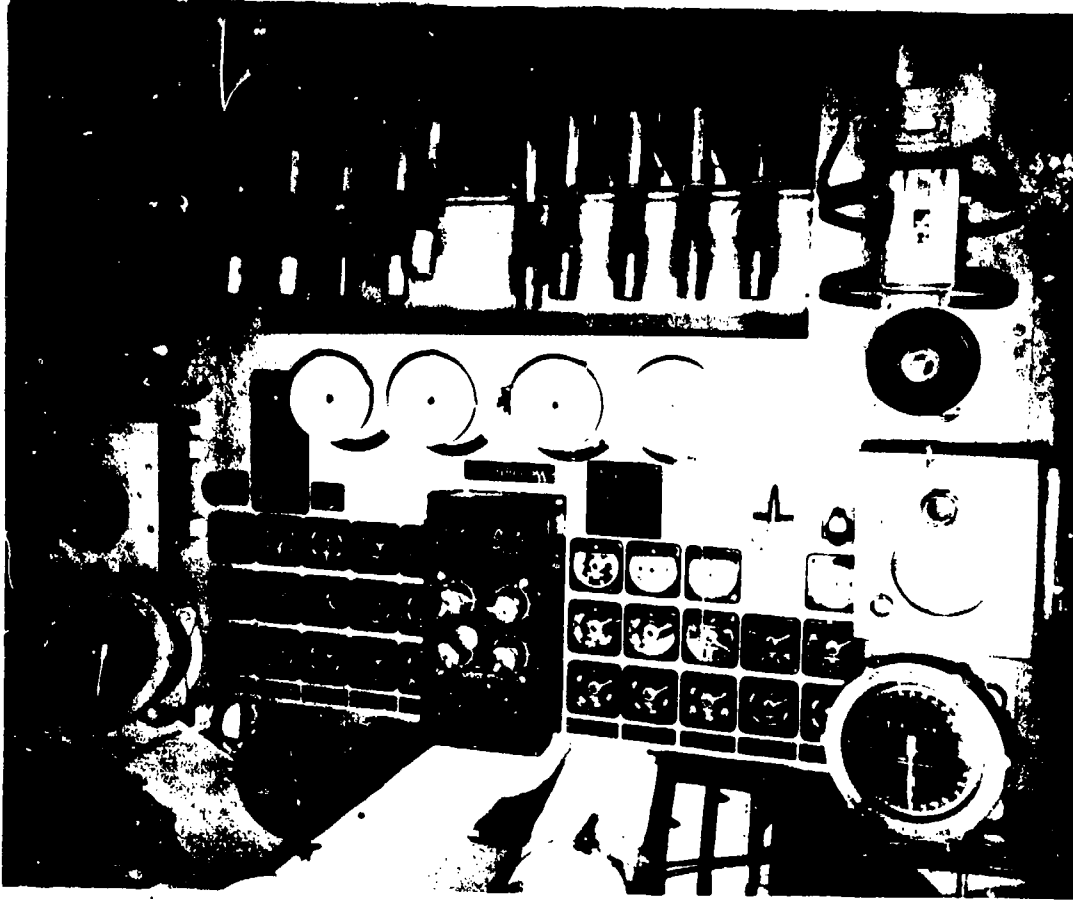
BA-CR56-33-1. View of main control board showing mounting of special timing relays on both sides on spring steel brackets.
